EVALUATION OF CODGELS CREEK MCB CAMP LEJEUNE NC  
11/1/1998  
CH2M HILL

# Evaluation of Cogdel's Creek

## Marine Corps Base Camp Lejeune, North Carolina

**November, 1998**

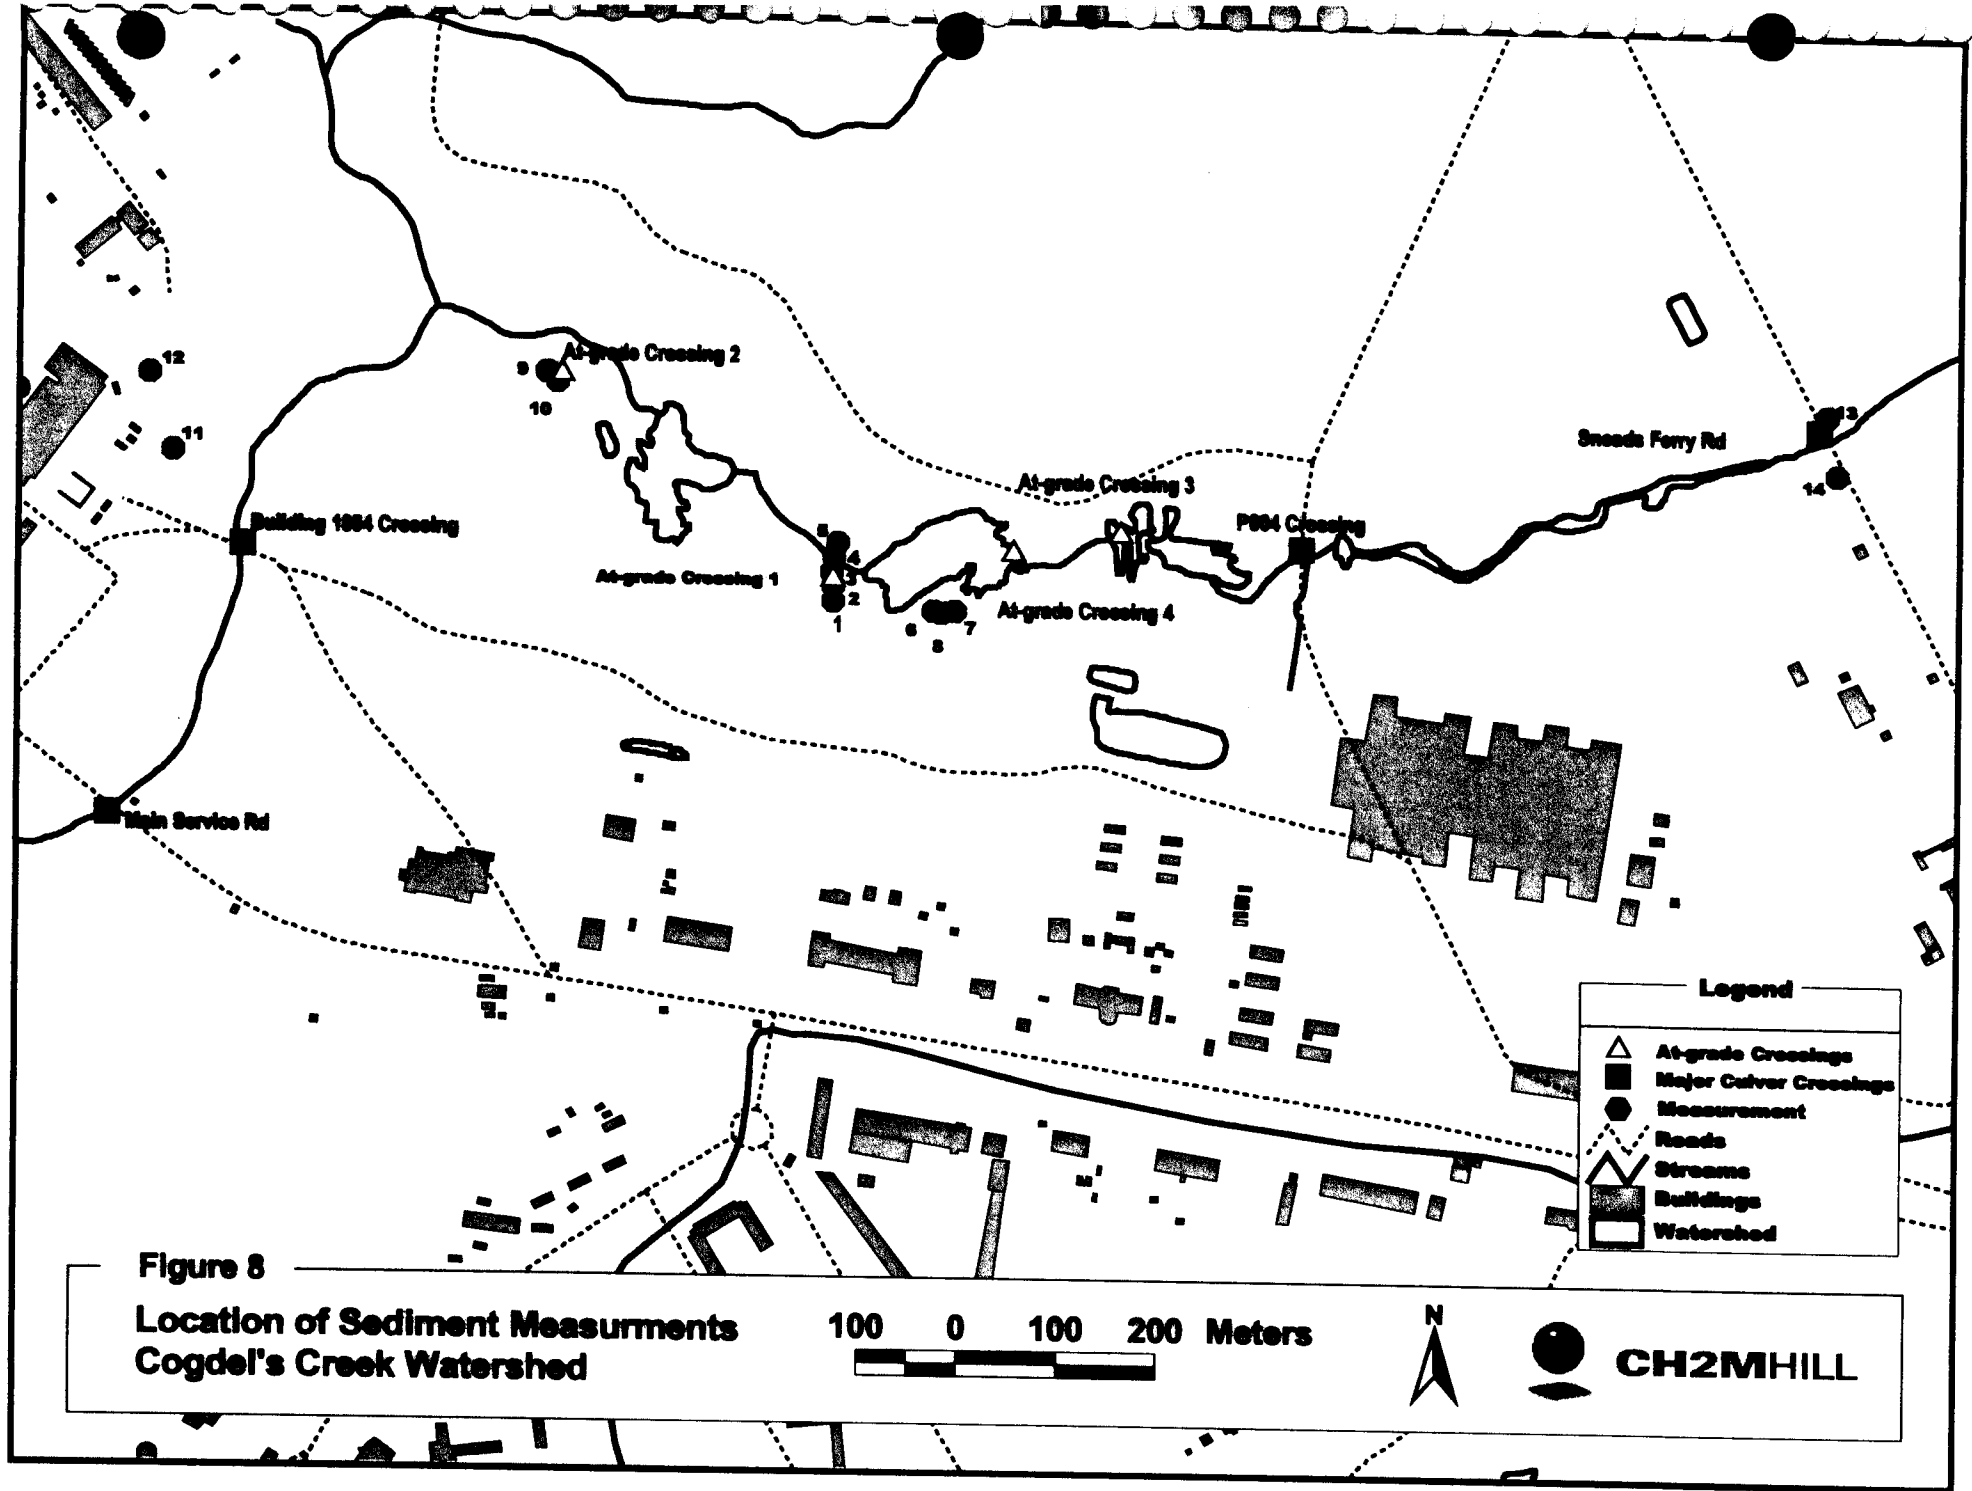
In order to estimate the total amount of sedimentation in Codgel's Creek, a hand auger was used to assess the depth of sediment at strategic locations. Figure 8 shows the locations where sediment depths were evaluated, and Table 5 summarizes the field observations. Using the field observations, along with the information in Figure 9 (based on topographic mapping and culvert inverts), cross sections were plotted for Site 14 (at-grade crossing 2) and Site 15 (at-grade crossing 1). Sketches of the cross sections are shown in Attachment B.

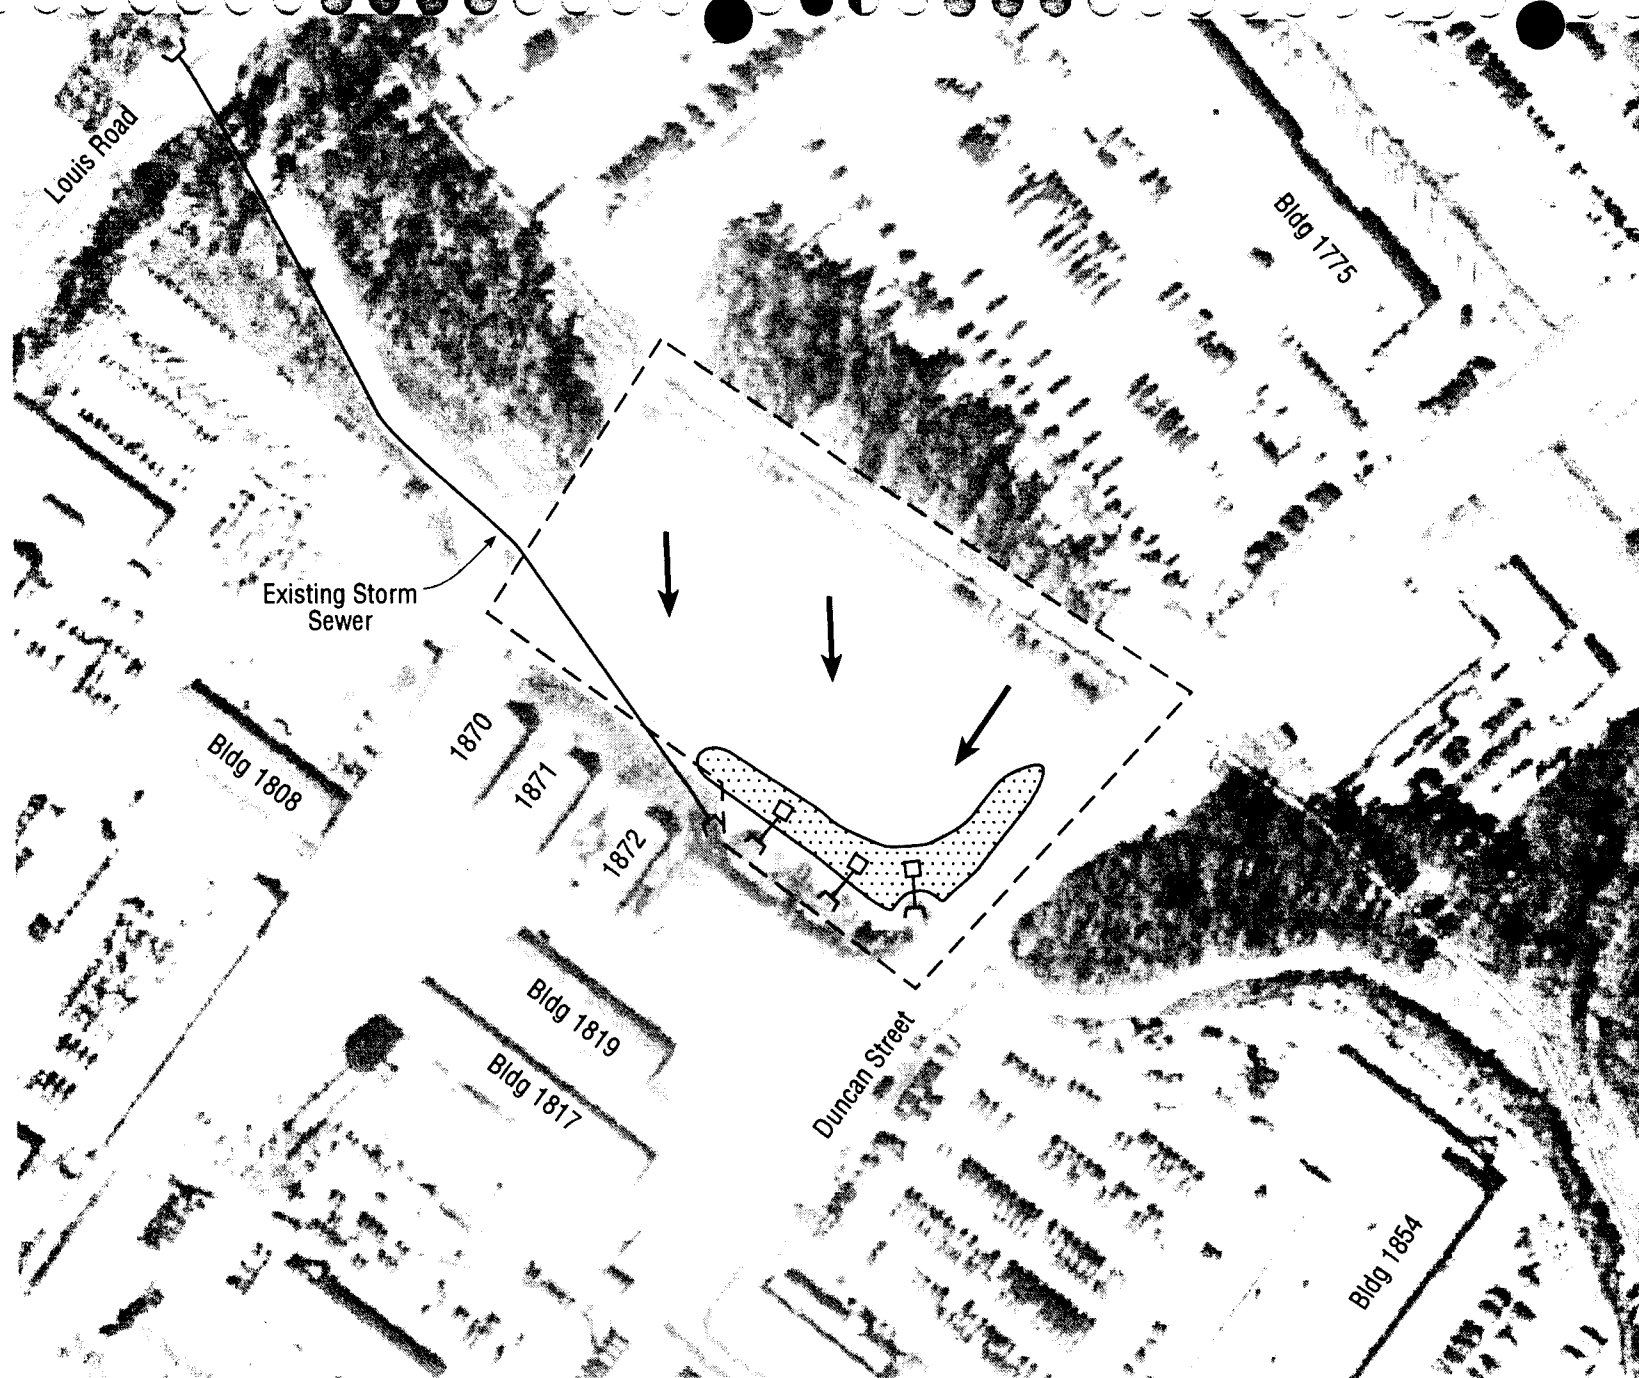
Figure 18  
Site 6: Building 1775 Area  
Cogdel's Creek  
**CH2MHILL**

The site is shown in Figure 18. Sedimentation has occurred upstream of the crossing due to the restriction in flow. Based on observed water surface elevations and nearby floodplain elevations, it is estimated that this segment of stream probably has an average sediment depth of two feet.

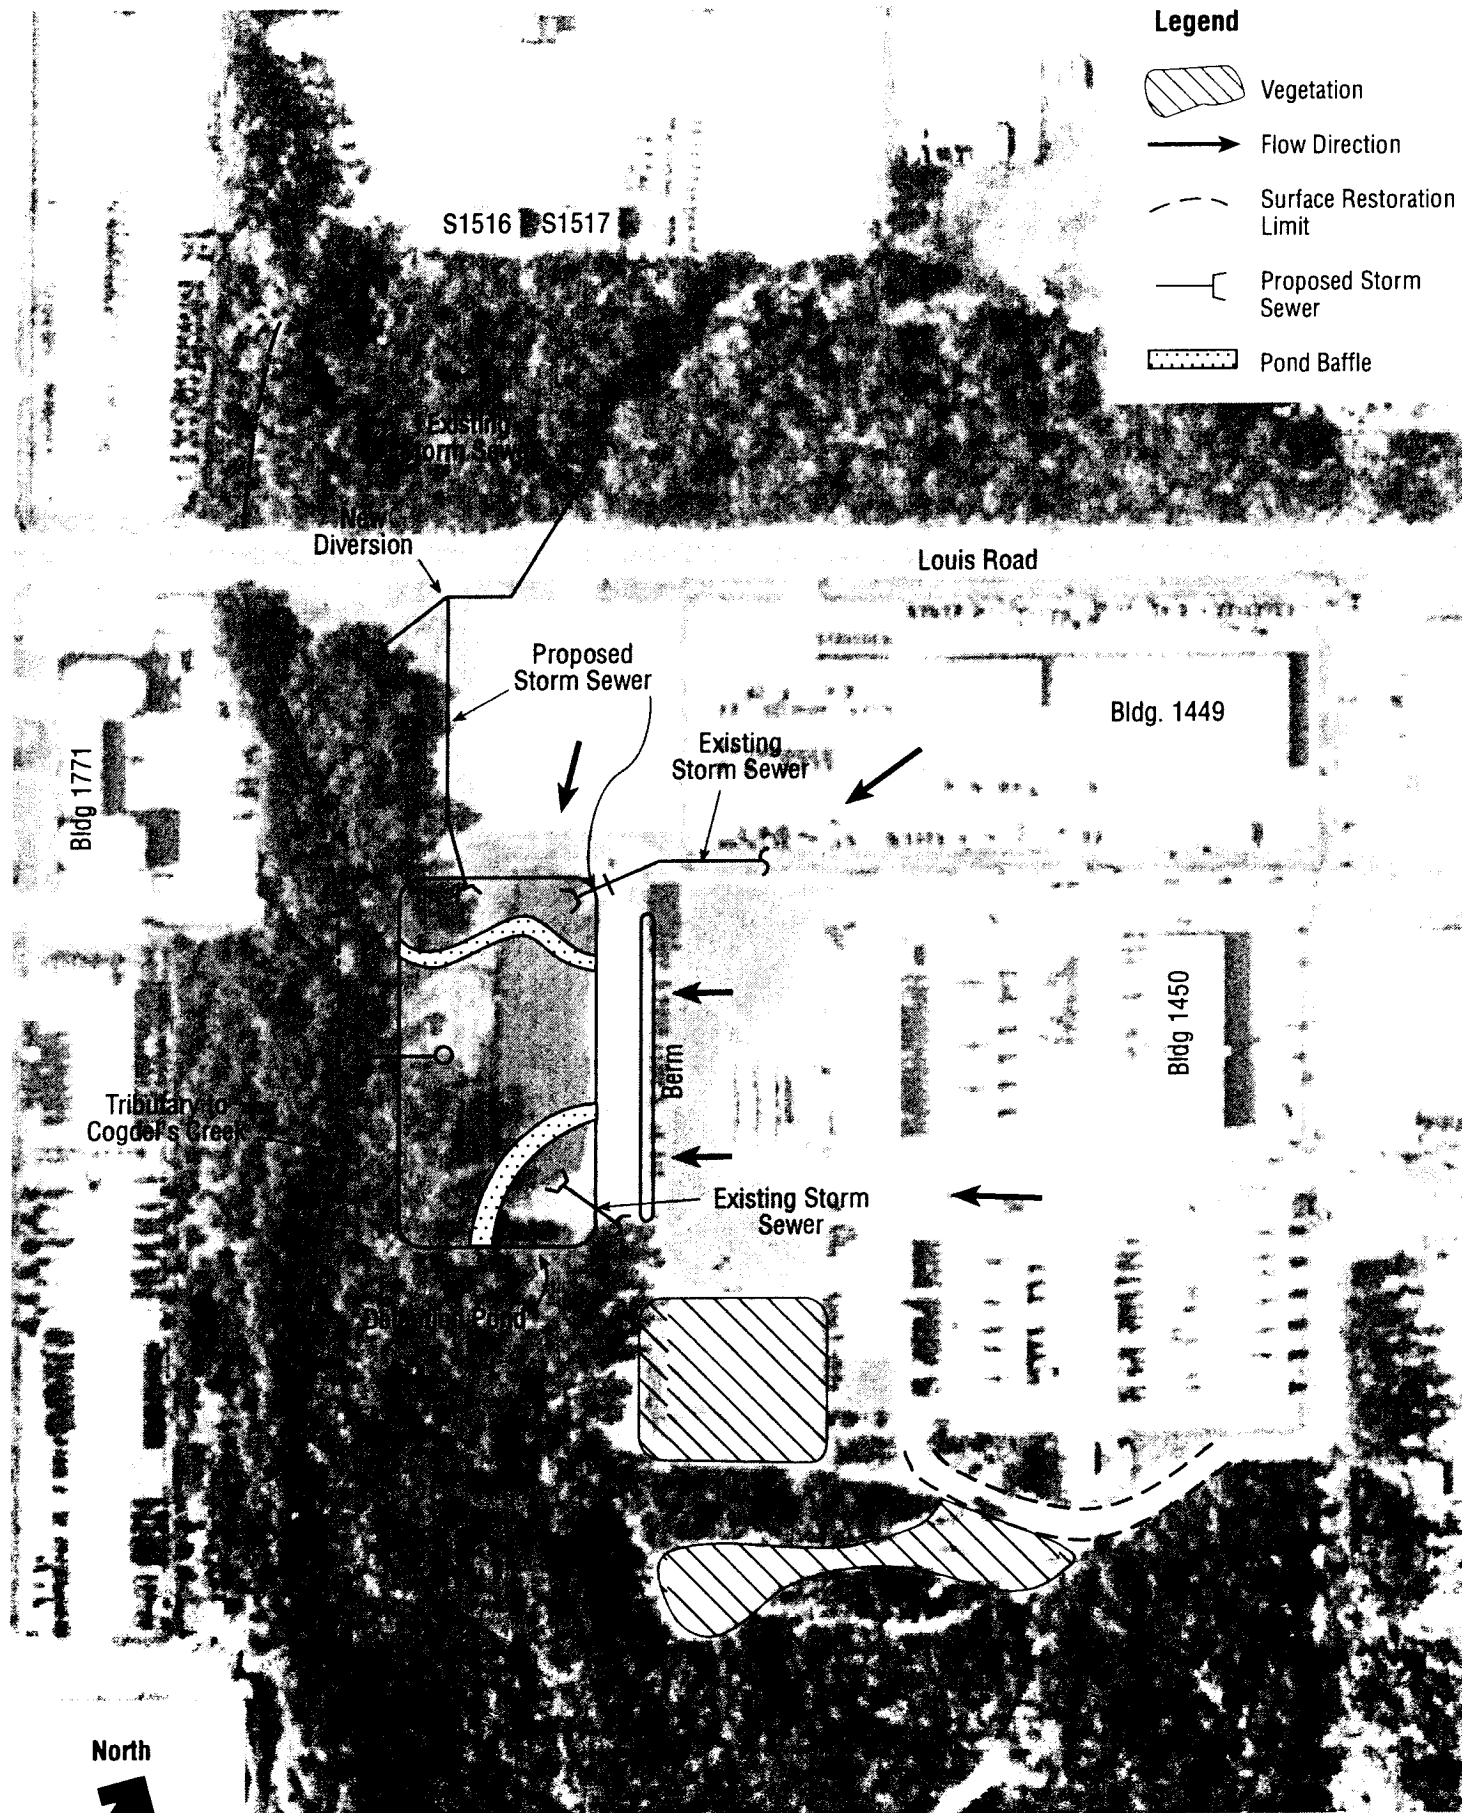
Figure 19  
**Site 7: Building 1450 Area**  
 Cogdel's Creek  
**CH2MHILL**

The site is shown in Figure 19. Sedimentation has probably occurred upstream of the crossing due to the restriction in flow. Based on observed water surface elevations and nearby floodplain elevations, it is estimated that this segment of stream probably has an average sediment depth of one foot.

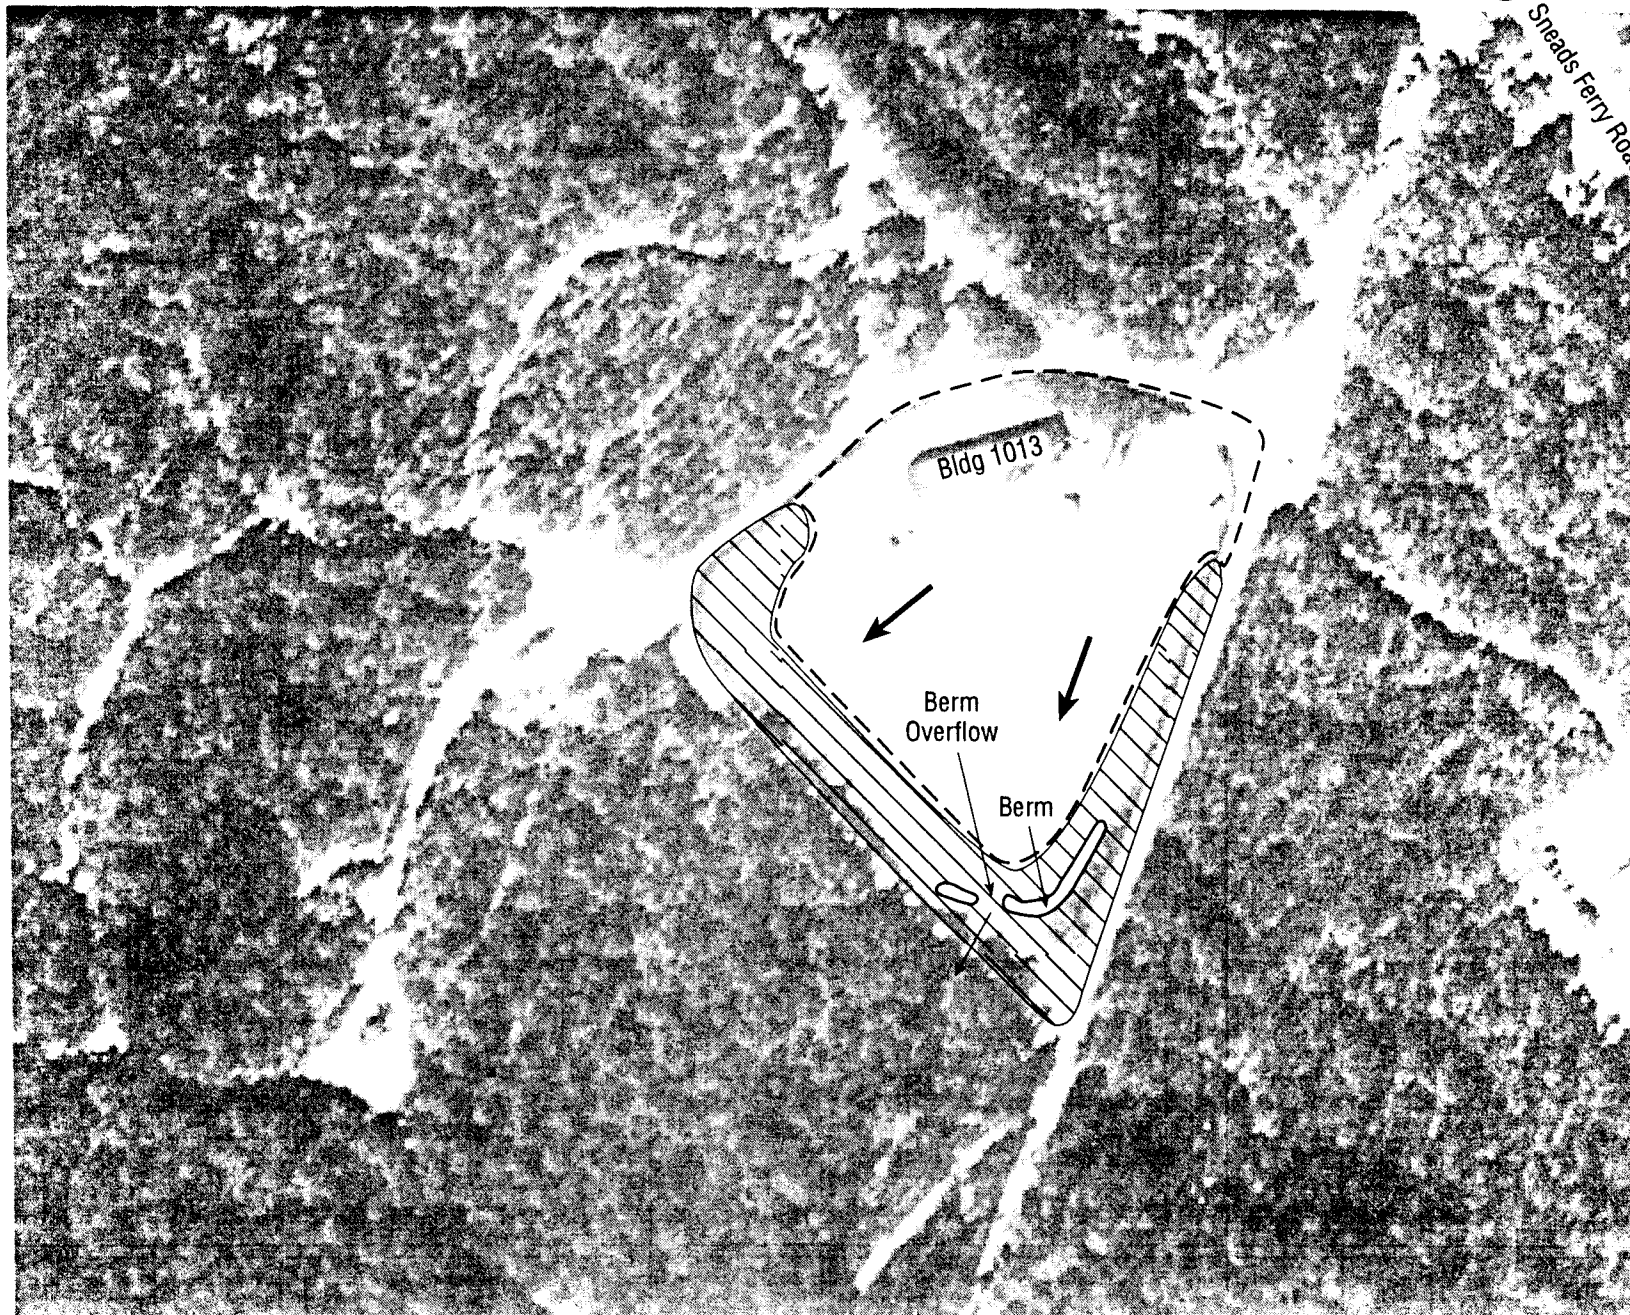
Figure 21  
**Site 9: 463L Pallet Loading Area**  
 Cogdel's Creek

This site, located south of Sneads Ferry Road in the midst of unimproved roads along Cogdel's Creek, encompasses over 7 acres. The site, shown in Figure 21, is 85 percent bare soil and appears to be used for equipment and vehicle storage. Runoff from the site is generally to the south toward Cogdel's Creek. A portion of the site (about one third) drains toward a dirt trail and flows along the dirt trail directly to Cogdel's Creek. The remainder of the site drains to the southwest through a wooded area and eventually into Cogdel's Creek. The site is 750 to 1000 feet from Cogdel's Creek.
